**RIVER WALL CONDITION ASSESSMENT AND
PRELIMINARY REPAIR COST ESTIMATE FOR
PROPOSED DUSABLE PARK DEVELOPMENT**

Chicago Park District

HARZA
Engineering Company, Inc.

March 2001

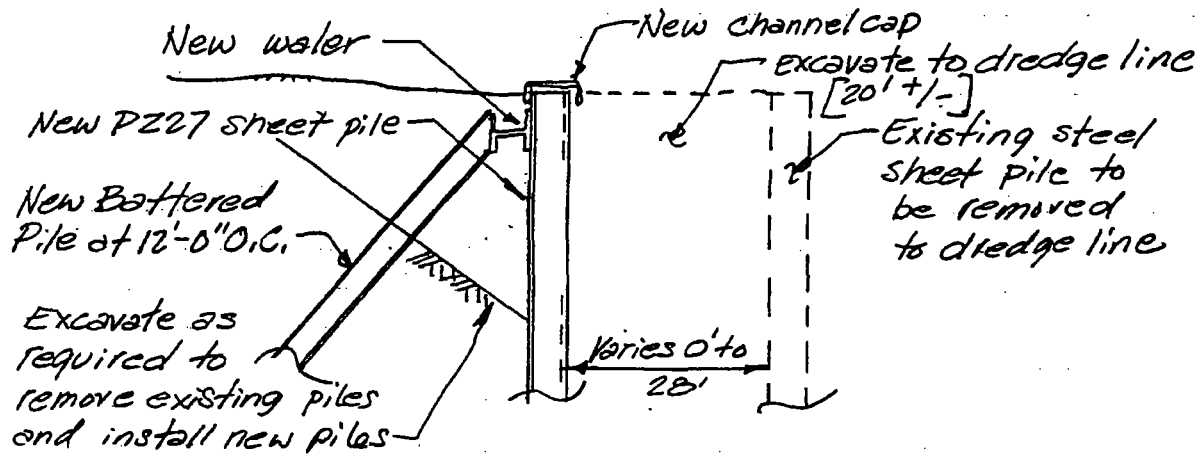
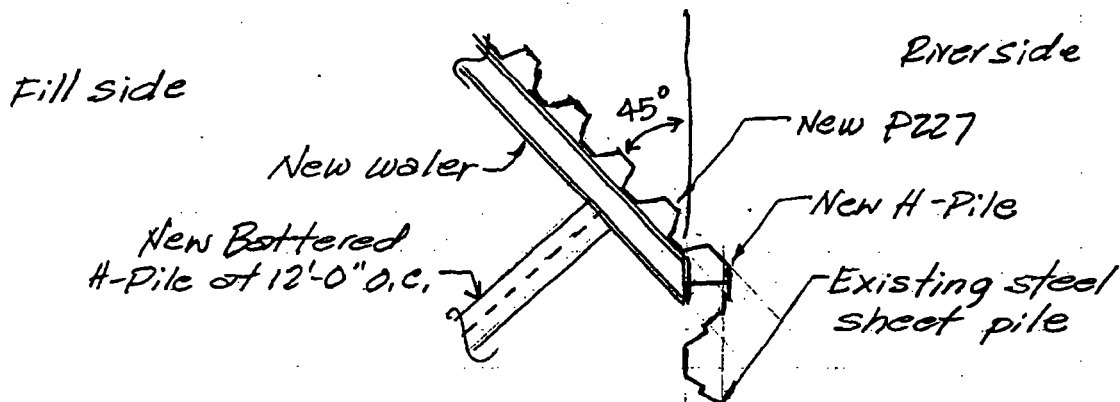
Southeast Corner Wall Replacement Section and Detail

The south east corner of the site was the most difficult to inspect due to the presence of large timbers across the top of the wall. In addition, facing timbers on the riverside of the wall prevented the inspection of protruding tie rods and other features. These same conditions were reported in the 1997 inspection. It appears that the south and east portions of the wall comprising this corner may have undergone some lateral movement. It appears that a more substantial repair may be required in this vicinity. A suggested repair detail has been developed and is described in Section 5. It is hypothesized that a contributing factor to the deterioration of this portion of the wall is the non-uniform stress concentrations and 3-dimensional soil-structure interaction that takes place at a 90-degree corner.

The southeast corner of the property is in need of repairs. This portion of the wall is the most difficult to inspect because of the presence of large timbers. It is suggested that wall replacement be implemented at this corner. The approximate extent of the existing wall that requires replacement is 40 feet north and 40 feet west of the corner as shown on Exhibit 3. The proposed repair comprises the installation of a new wall and the demolition and removal of the existing wall. A section and detail of the proposed repair is shown on Exhibit 4. The repair detail comprises a new steel sheet pile wall, supported with batter piles as shown. At each end of the repair vertical H-piles are recommended to help tie the repair into the existing wall. A cost effective solution is to build a diagonal wall across the inside of the corner. Using this arrangement (and assuming that 40' x 40' corner is to be repaired) the replacement wall will be approximately 60 feet in length and will replace 80 feet of existing wall. This will result in the loss of about 800 square feet of the property (0.02 acres, less than 1%). Reconstruction of the existing corner with a diagonal wall is likely to be a preferable long-term solution and will better match the northeast corner as well as being about 20% cheaper than replacing the existing corner in-kind.

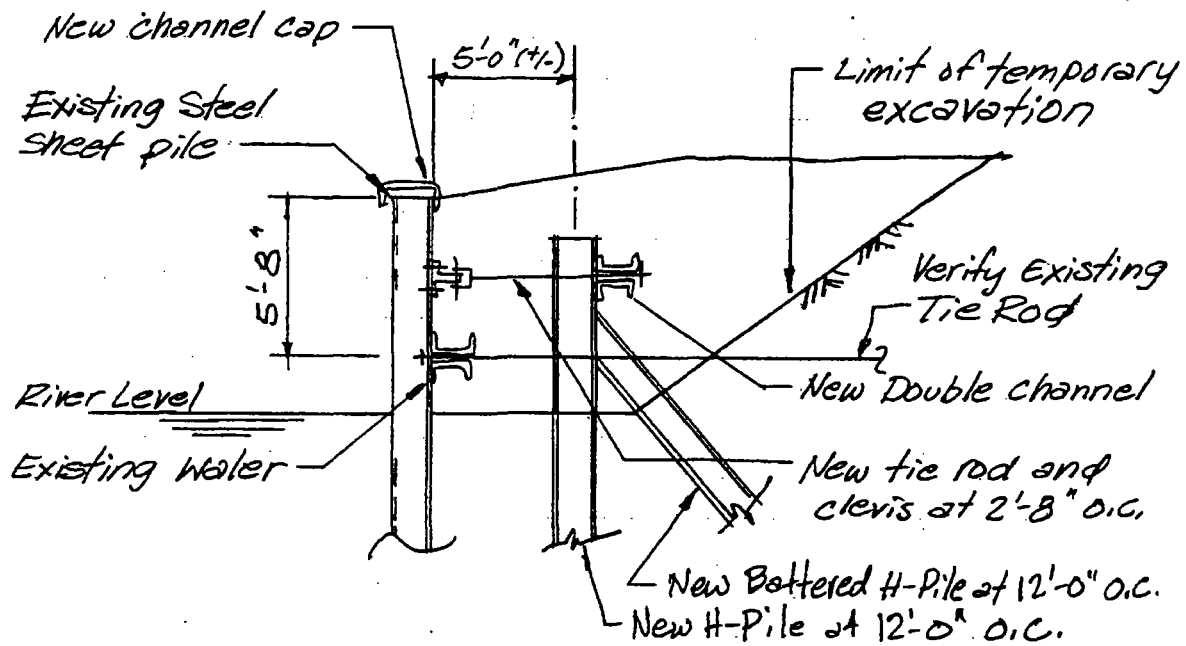
EXHIBIT 5
Proposed North Wall Stabilization Measures
Typical Section

There is significant deterioration on portions of the north wall, including a section of wall that is bulging and several areas of pronounced corrosion. The conditions, as visible from the above ground inspection, do not appear to have worsened significantly from the time of the previous inspection. A suggested repair detail has been developed and is described in Section 5.

A portion of the north wall is bulging northwards towards Ogden Slip. This condition was reported in the 1997 inspection and does not appear to be deteriorating rapidly. A repair detail is shown on Exhibit 5. The proposed repair entails driving new supporting piles landward of the bulging section that would act to relieve some of the load on the wall and could bring it back into alignment. Prior to installing the supporting piles the area immediately behind the wall would be excavated to an elevation below the tie rods, and broken or missing tie rods could be replaced. The extent of the repair is estimated to be about 30 feet. The existing condition of the tie rods (presently buried and not visible) may require a larger portion of the wall to be repaired.

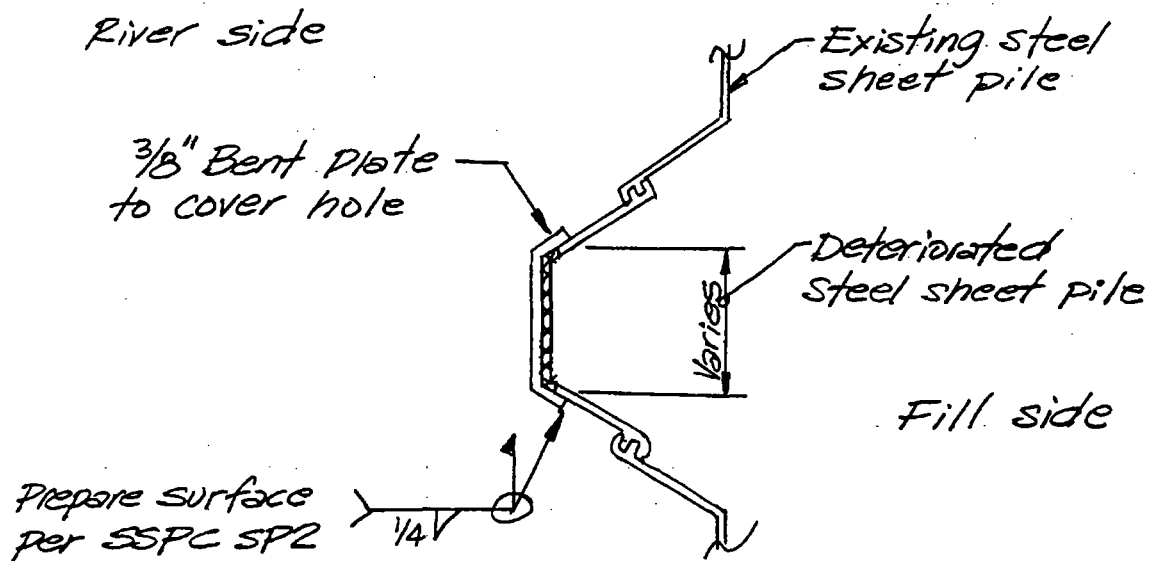
EXHIBIT 6
Typical Wall Patching Detail

The majority of the south wall appears to be in generally good condition with the exception of a couple of severely damaged individual piles at around the midpoint of the wall. Since this wall forms the north bank of the Chicago River navigation channel it is more exposed to the potential for damage due to vessel collision than other portions of the wall. It is hypothesized that the individual pile damage along this wall has been caused by such collisions. In addition, this wall is known to have been used in the past as a mooring location for barges. A typical repair detail for these conditions has been developed and is described in Section 5. A more detailed survey from the waterside is needed to locate and size the complete extent of such damage.

Wall patching is recommended for certain individual or groups of sheet piles throughout the south wall. A typical detail is shown in Exhibit 6. The repair requires surface preparation of the sound steel surrounding the area to be patched and the welding of a bent plate over the damaged area. The most serious damage is located about 180 feet east

Wall patching is recommended for certain individual or groups of sheet piles throughout the north wall, as previously described for the south wall. A typical detail is shown in Exhibit 6. The repair requires surface preparation of the sound steel surrounding the area to be patched and the welding of a bent plate over the damaged area. The most serious damage is located about 80 feet west of the northeast corner. A single pile has been cut and requires patching. A more extensive waterside inspection is required to more precisely quantify the total area of patching required. The initial estimate is that approximately 20 square feet of patching will be required which corresponds to about 1% of the above water area of sheet pile.
